# ANALYSIS OF CASE STUDIES IN RECOVERY AND RECONSTRUCTION CASE STUDIES

# FLOOD PROTECTION PROVISIONS IN THE WORLD HERITAGE CULTURAL LANDSCAPE WACHAU, FOLLOWING THE FLOOD OF 2002

Michael Schimek, Dipl.-Ing. MA

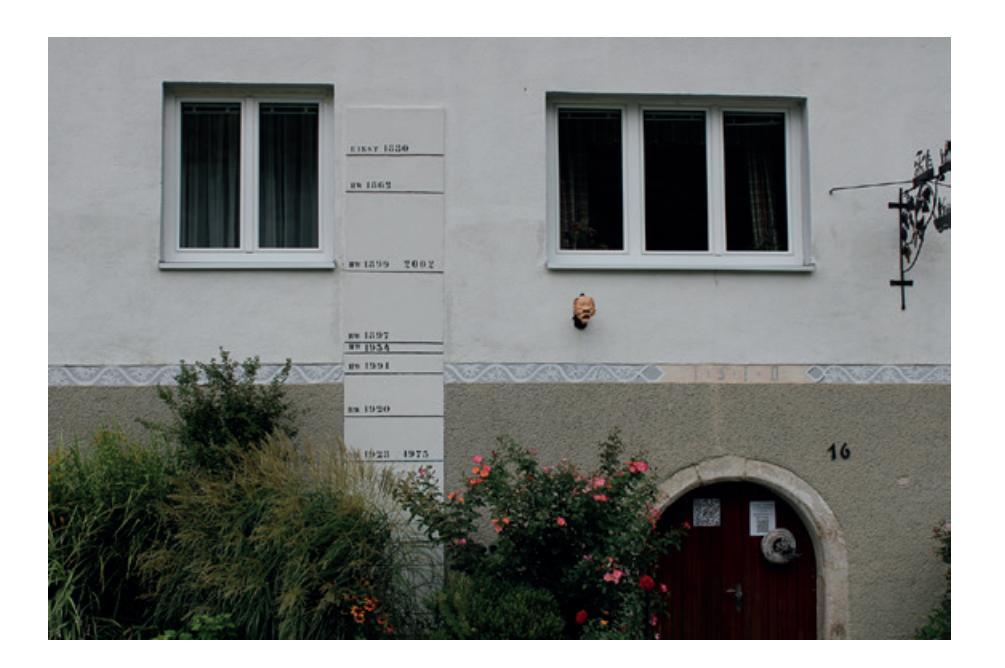
**Fig. 2.** M. Schimek, 2019, Flood marks at the house Oberarnsdorf 16

Around 1800, there were again a number of rather large floods, such as in 1787, 1830, and 1862, partly caused by ice jams (see fig. 2).<sup>3</sup> At the same time, the use of the Danube followed the industrialisation of society, meaning the river should become more reliable for navigation and at the same time safer for the local people in the event of a flood. This is why the Danube in Austria was, as it was called, "regulated" (*reguliert*) during the second half of the nineteenth-century, which mostly meant cutting off side branches, putting the water into one rectified river bed and securing the banks with big rocks.

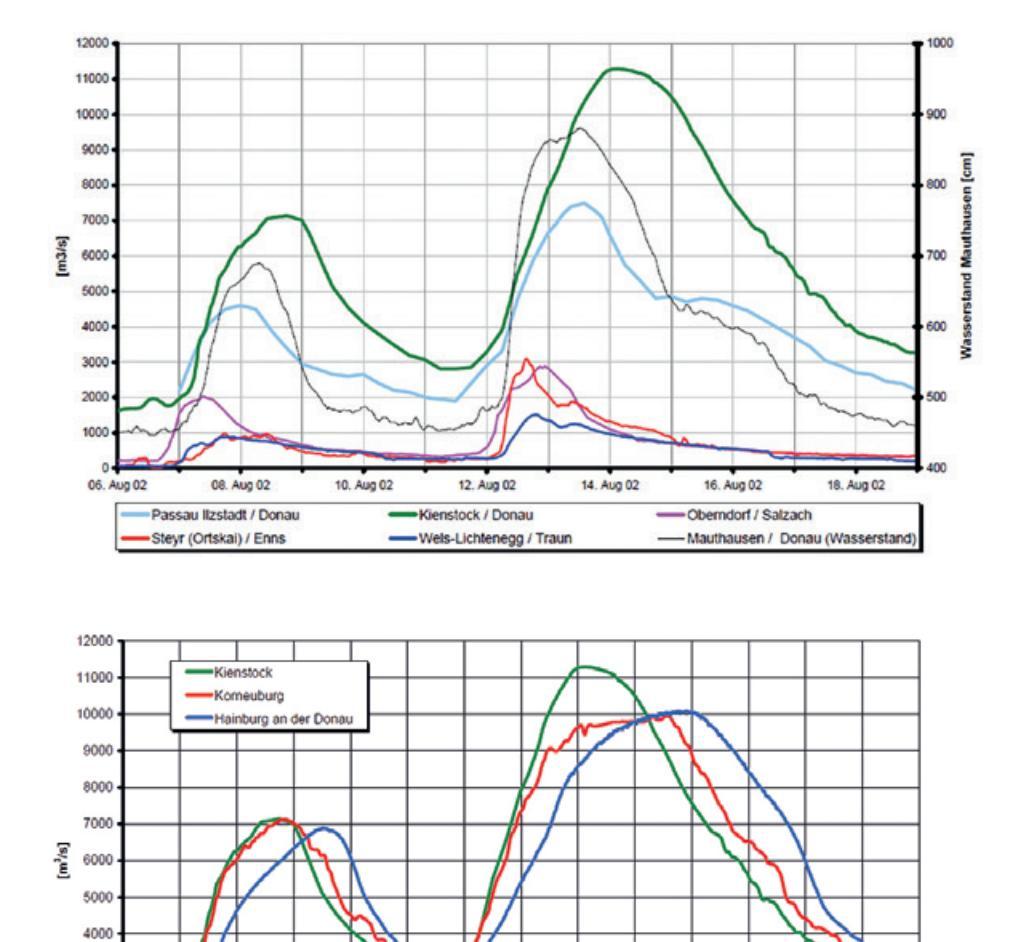
In the end, it was two events within a week that caused the enormous impact of the flood in the Wachau in August 2002. The first event took place on 6 and 7 August. 2002. Extremely heavy rainfall north of the Danube – in some places there was almost three times as much rain in 48 hours than there usually was for the whole month of August<sup>9</sup> – caused a 1000-yearly flood (fig. 3) in some places.

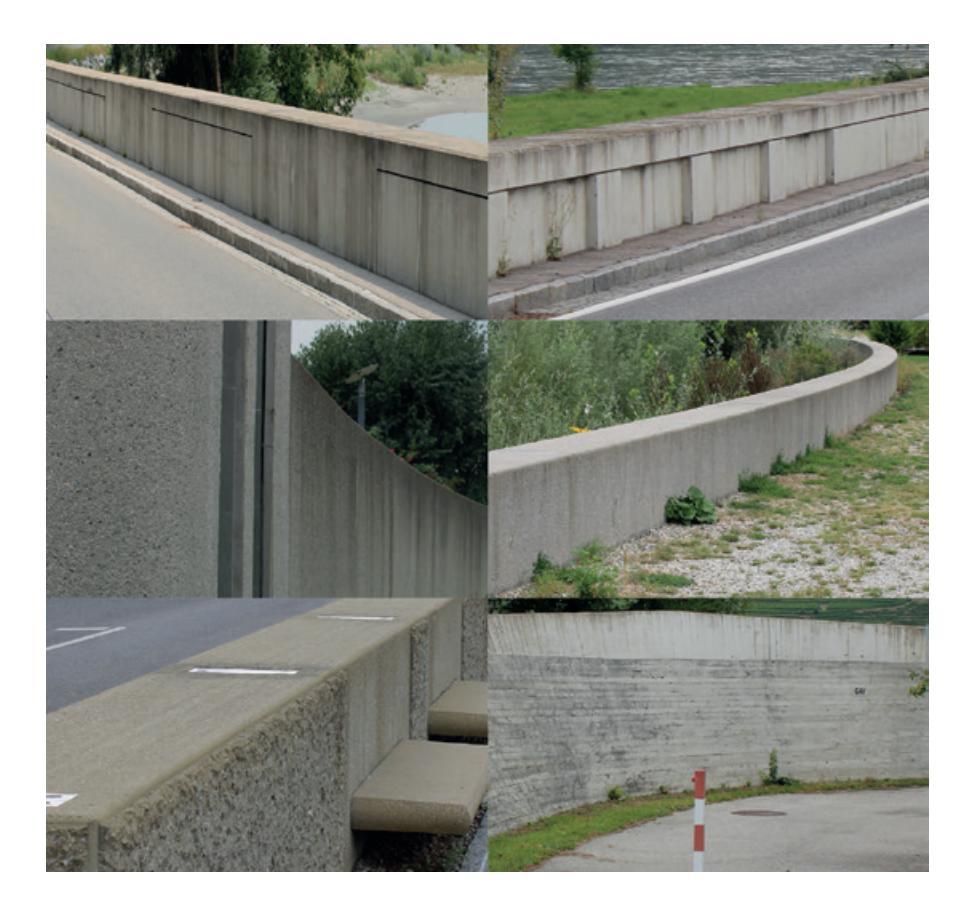
**Fig. 13.** M. Schimek, 2019, Different wall designs

As for the design of the walls, the decision was taken that they should be recognisable as a twenty-first-century intervention and not be designed in a historicising manner. This led to different aesthetic solutions, though, depending on which architect the municipality chose for the job (fig. 13).

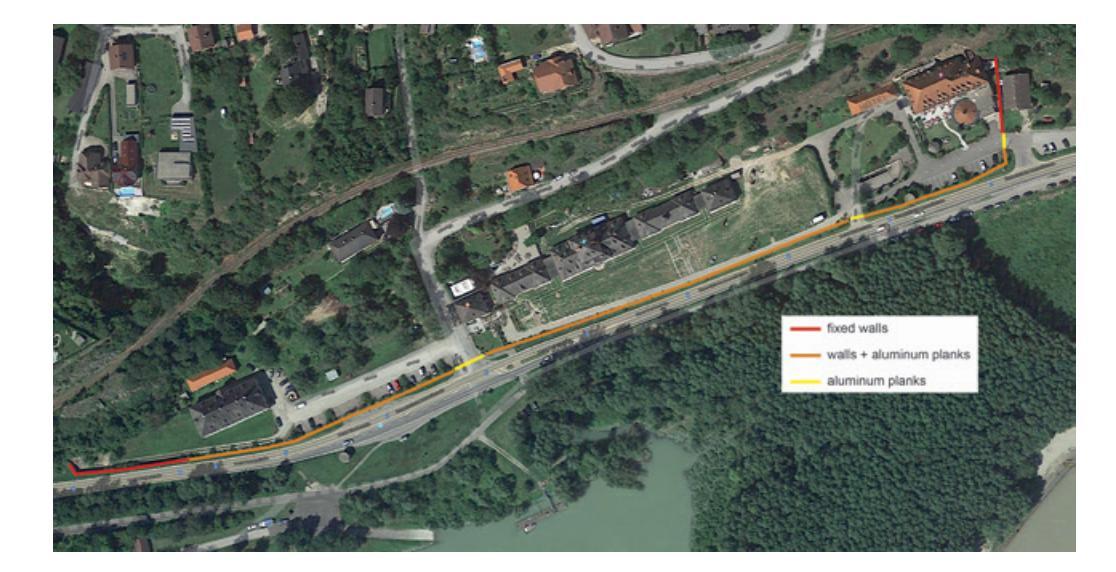
Fig. 14. Google Maps, cartography M. Schimek, 2019, Flood protection system at Luberegg

The first new flood protection system that was built happened without any involvement of the regional level and without the support of the local municipality. It was privately erected by the owners of Luberegg castle, the Pichler family.

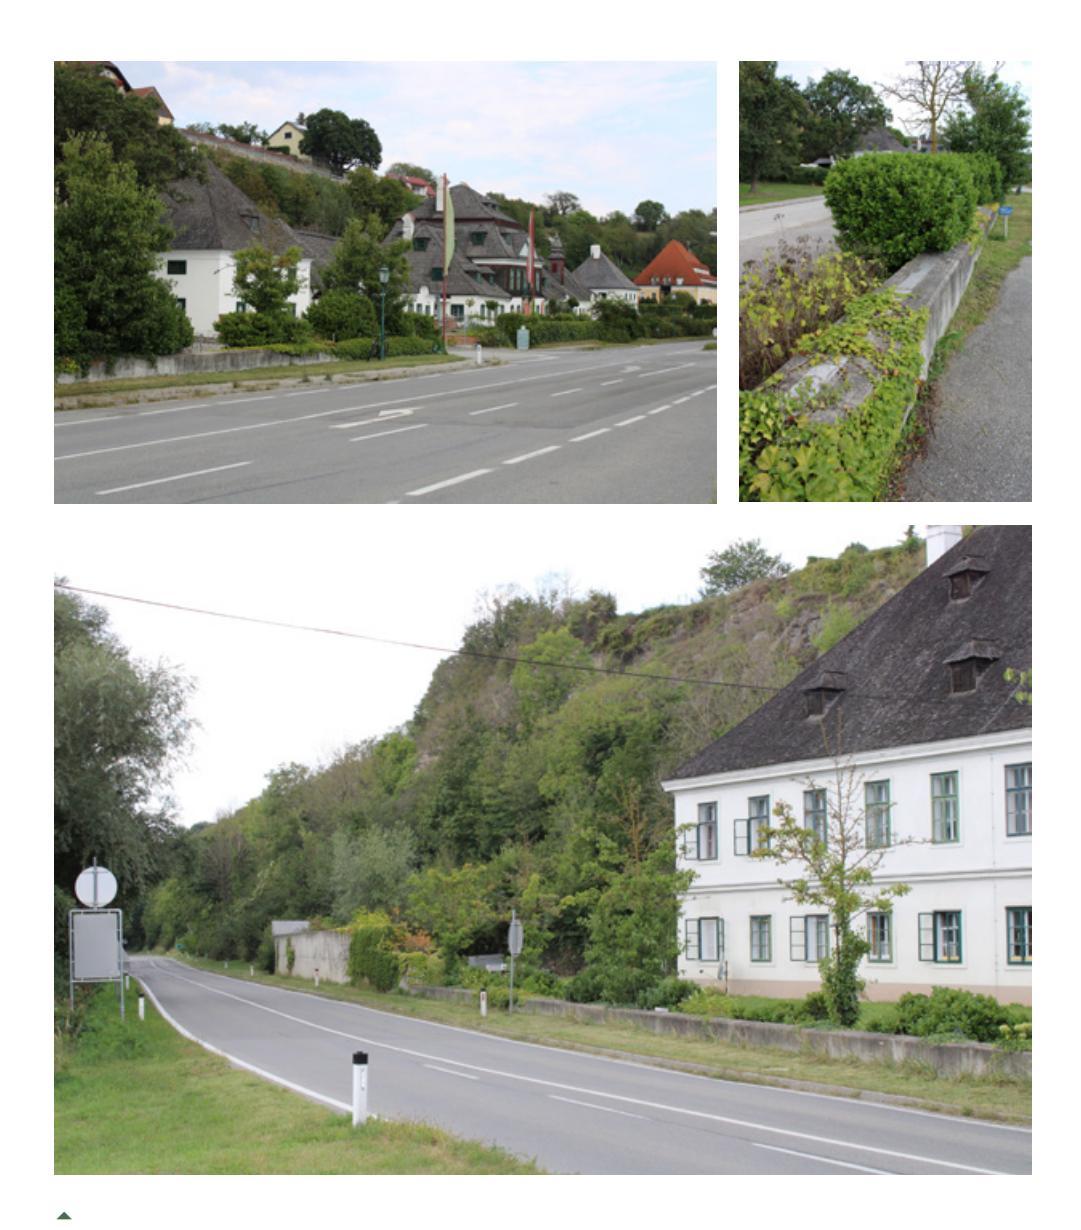
Fig. 15. M. Schimek, 2019, Luberegg castle and the flood protection wallFig. 16. M. Schimek, 2019, The flood wall replaced the garden wallFig. 17. M. Schimek, 2019, Flood gate at Luberegg

In 2003, Josef Pichler, owner of a number of hotels in the municipality of Emmersdorf, bought the estate and directly after that started to look for funding for protecting the castle from future floods. He was supported by the Republic of Austria and the federal state of Lower Austria. The protection infrastructure was designed in the style of most of the other public protection systems later (fig. 15), in this case replacing the garden walls of the castle by a low concrete wall on which aluminium panels can be screwed for the final height of the system (fig. 16). Only in the westernmost corner and to the side of the already existing Landhof Hotel were higher walls erected (fig. 17).

The aluminium panels are privately stored and mounted in case of emergency. The system was finished in 2006.<sup>20</sup> The whole infrastructure is about 500 m long.<sup>21</sup>

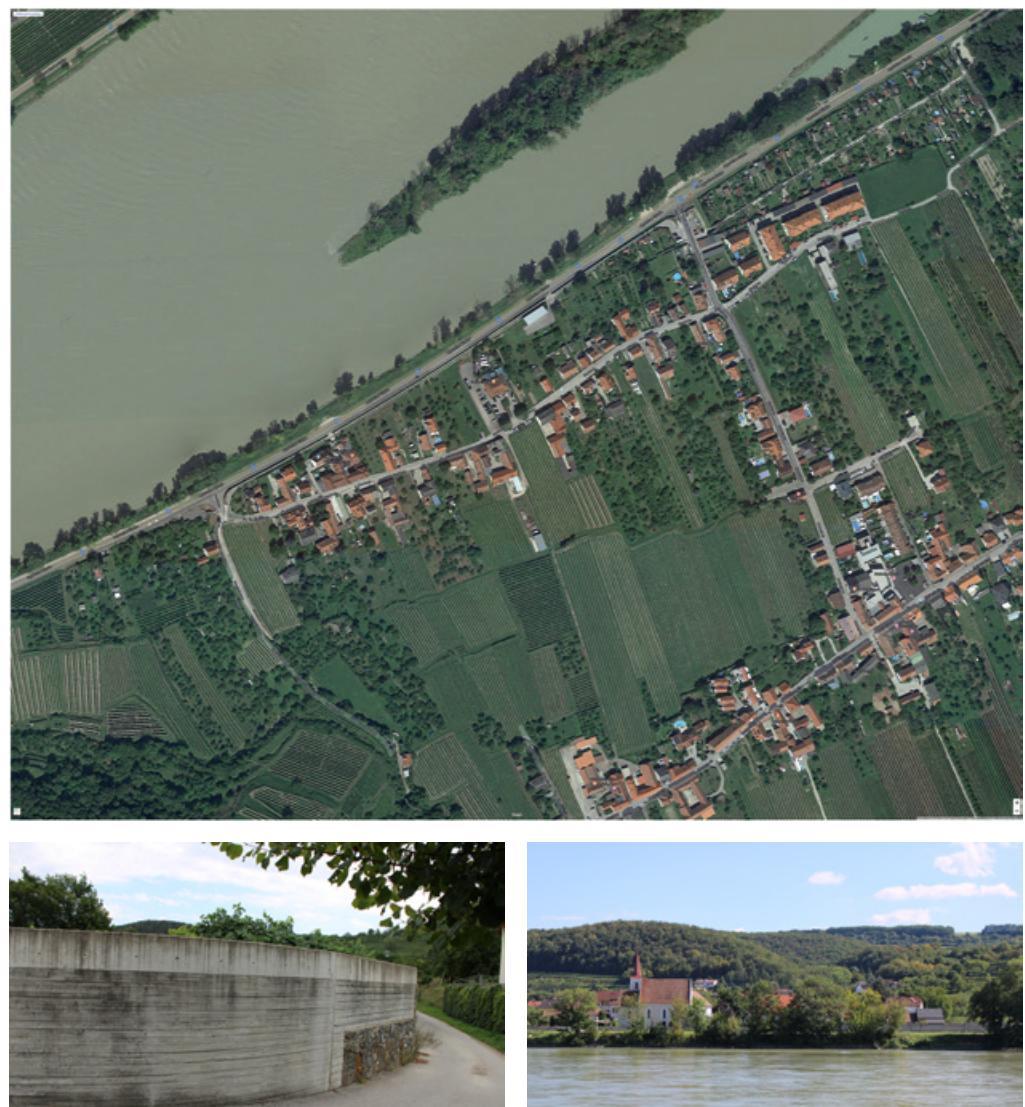
from top: Fig. 18. Google Maps, cartography M. Schimek, 2019, Flood protection system at Hundsheim Fig. 19. M. Schimek, 2019, Hundsheim chapel and the flood protection solution around Fig. 20. M. Schimek, 2019, Upper corner of the flood protection at Hundsheim

## 4.2.3.2. Hundsheim (fig. 18)

The small village of Hundsheim belongs to the town of Mautern, opposite the town of Krems-Stein. In this case, the municipality council of Mautern started their plans to build a flood protection system without discussing it with the regional board. Thus, everybody was very surprised when they presented a draft which planned to build only fixed walls, most of them 3 to 5 m high.

The personal effort of the officer-in-charge of the Federal Monument Protection Authority (Bundesdenkmalamt) made those plans public and caused a redesign of the initial draft. In front of the historic chapel of Hundsheim, the fixed wall was replaced by the lower wall and aluminium panel version (fig. 19).

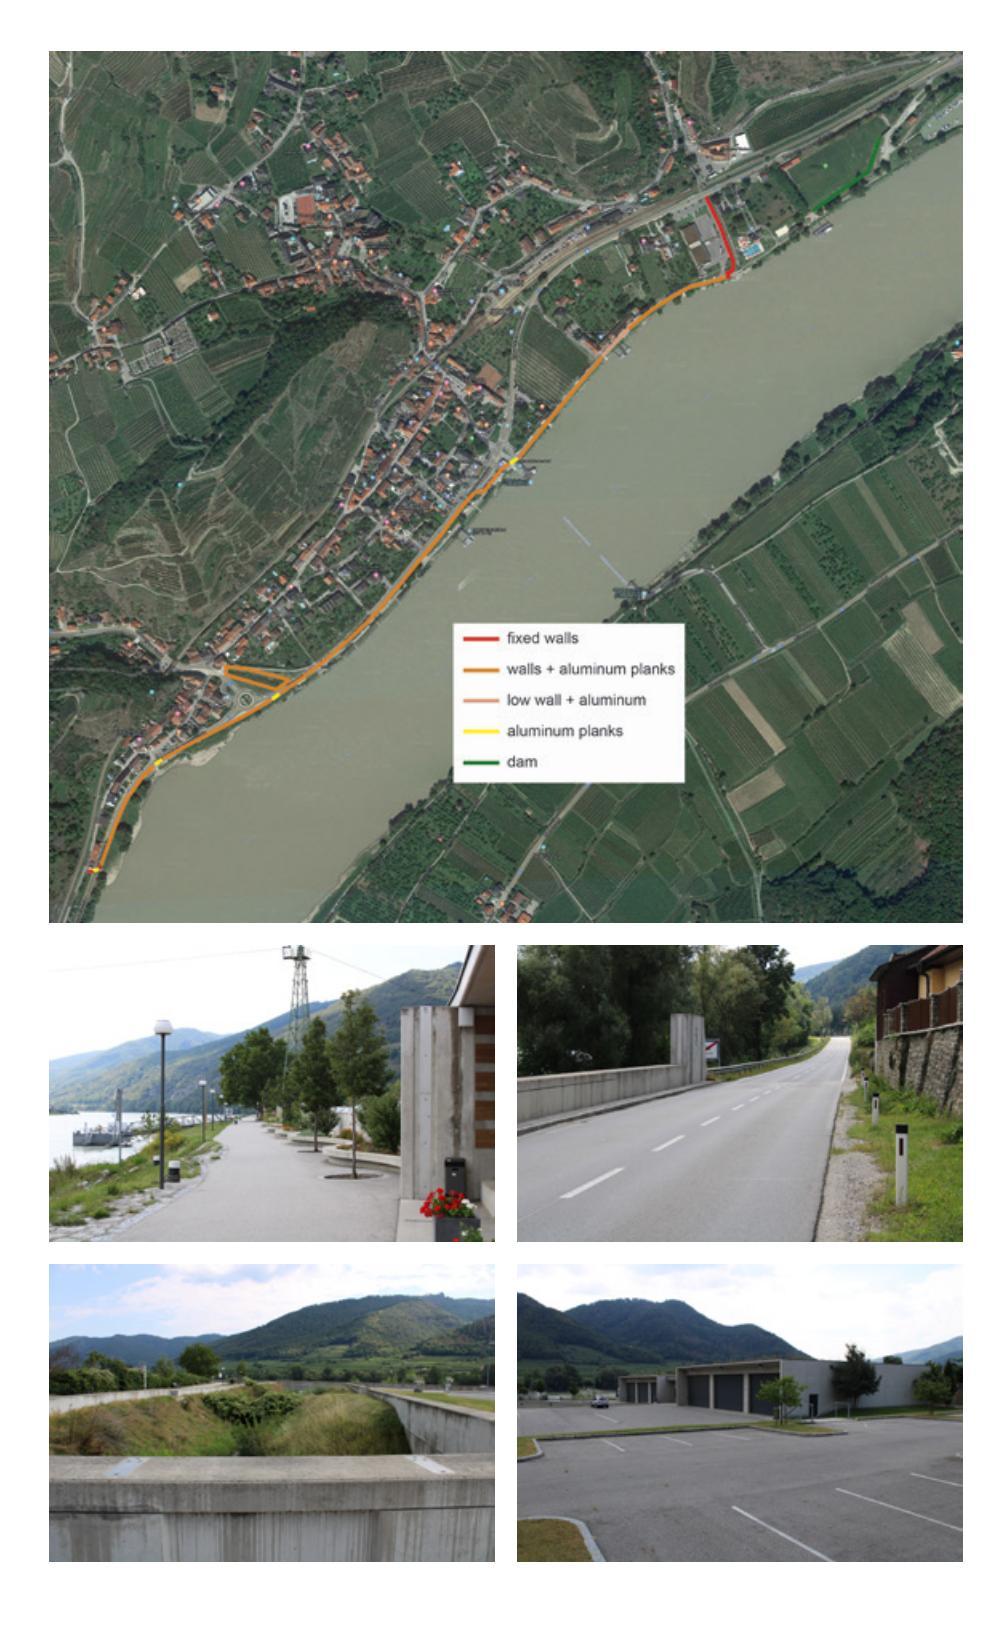
Unlike Weißenkirchen, Spitz used the opportunity of the flood protection building to redesign the public space between the wall and the Danube. A number of leisure elements were integrated into the wall (fig. 29); a new service house replaced the former ship cruise ticketing shed, and the design of the waiting zones for the public buses was similar to the other new buildings along the Danube. The area around the storage halls was turned into visitor parking for people coming to Spitz – an added benefit as there was previously a severe shortage of parking spaces.

Building the system in Spitz started in  $2010^{32}$  and took two years.<sup>33</sup> It cost about  $\notin 28$  million<sup>34</sup> and is 1.8 km long.<sup>35</sup>

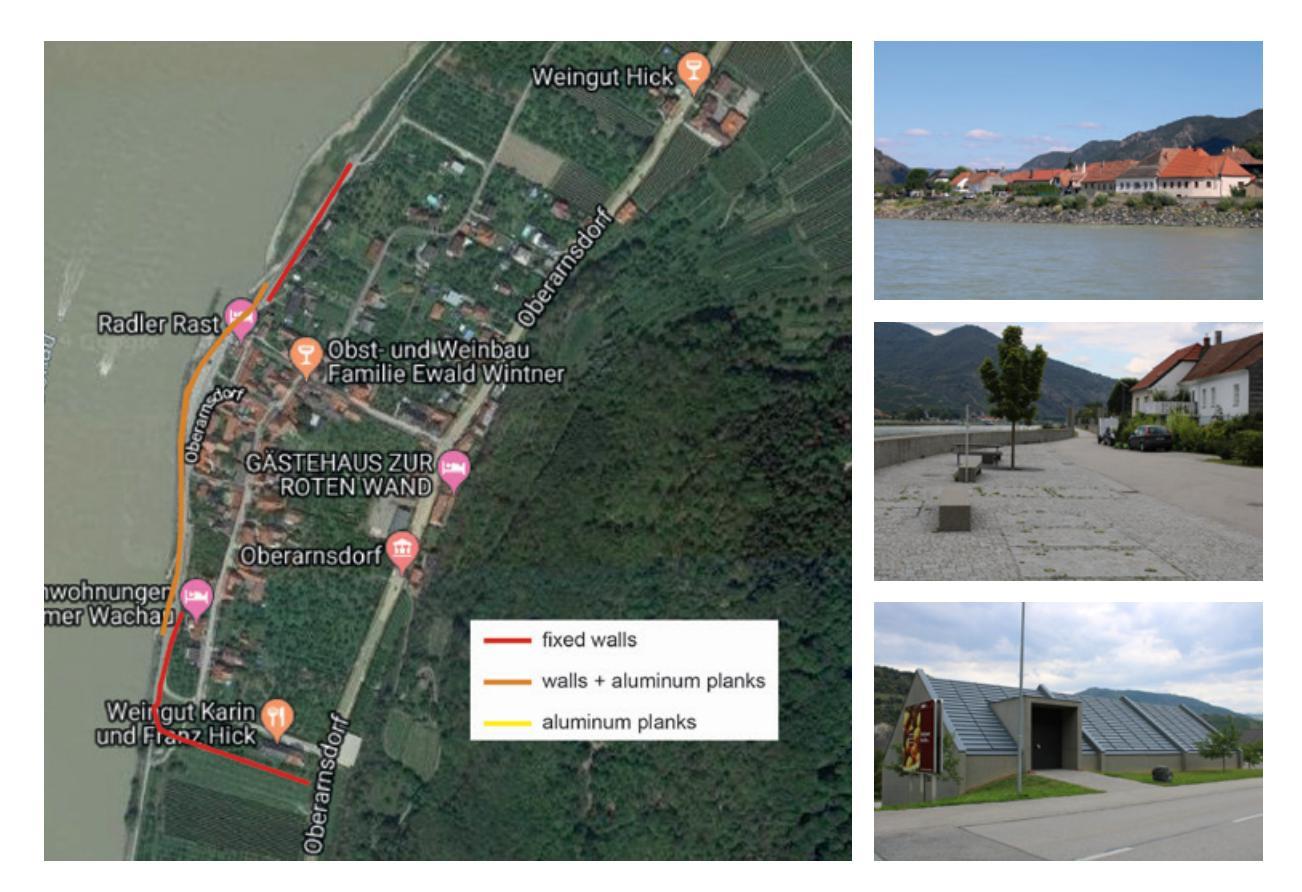
The storage facility for the aluminium panels was located in the backyard of one of the old village houses. It was built into a steep gradient from the main road, so that the building looks modest from the street side (fig. 33). The real extent is only visible when driving down the hill – this view is obstructed from the village and the Danube, though, so it does not have any impact on the visibility of the World Heritage site.

Building the system in Oberarnsdorf started in 2011 and was finished in 2012. It cost about  $\notin$  9.7 million<sup>36</sup> and is 870 m long.<sup>37</sup>

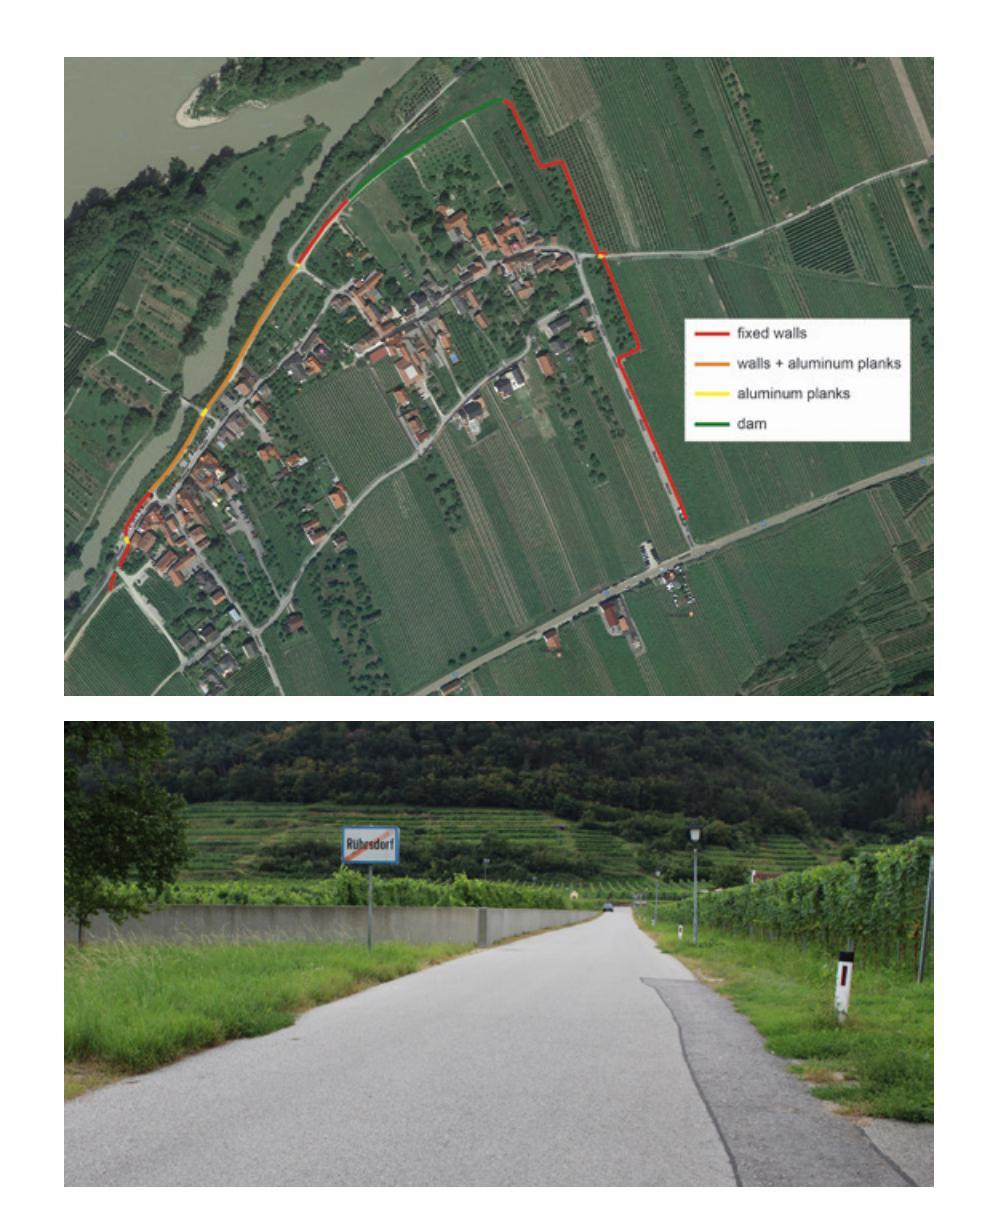
Fig. 34. Google Maps, cartography M. Schimek, 2019, Flood protection system at Rührsdorf Fig. 35. M. Schimek, 2019, Walls are needed deep into the vineyards because of the flat land surrounding Rührsdorf

### 4.2.3.6. Rührsdorf (fig. 34)

Rührsdorf, another village of the municipality of Rossatz-Arnsdorf, started to build its flood protection system at the same time as Oberarnsdorf.

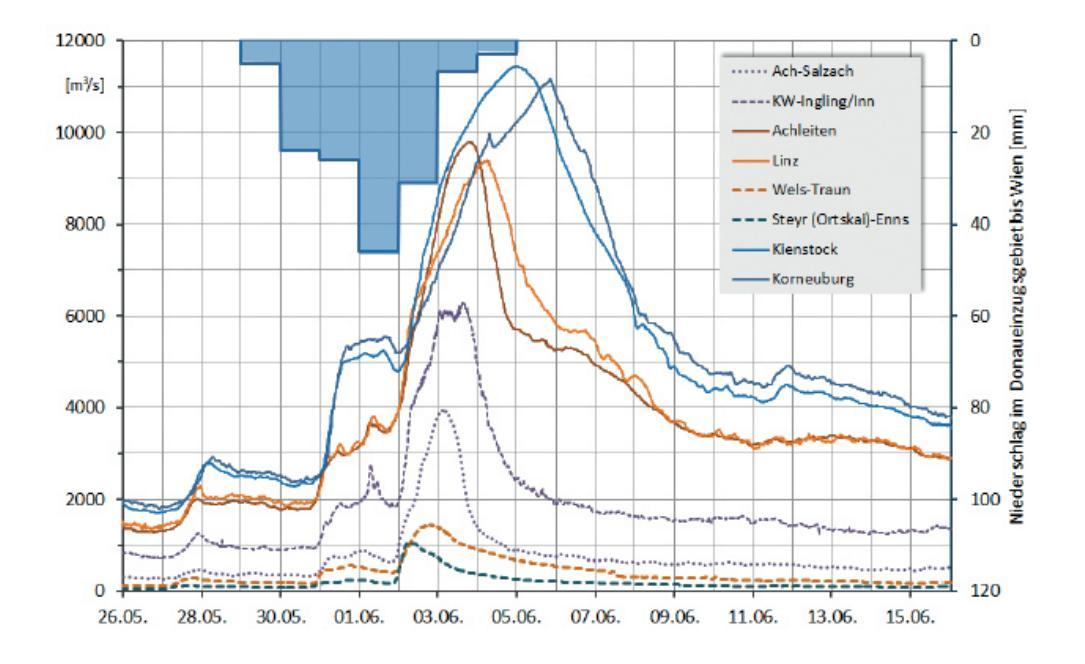
**Fig. 37.** The June 2013 flood on the Danube, in: Godina *et al.* 2014, 32

Because of the "modified release" of the precipitation that first fell as snow, the whole flood event lasted for six days this time, similar to the flood of 1954 (fig. 37). The maximum amount of water passing through the Wachau was calculated at 11,450 m<sup>3</sup>/s, which was even slightly more than in 2002. Nevertheless, the maximum

peak of the flood was recorded at 10.81 m at the measuring station in Kienstock, which was 12 cm less than in 2002.<sup>43</sup>

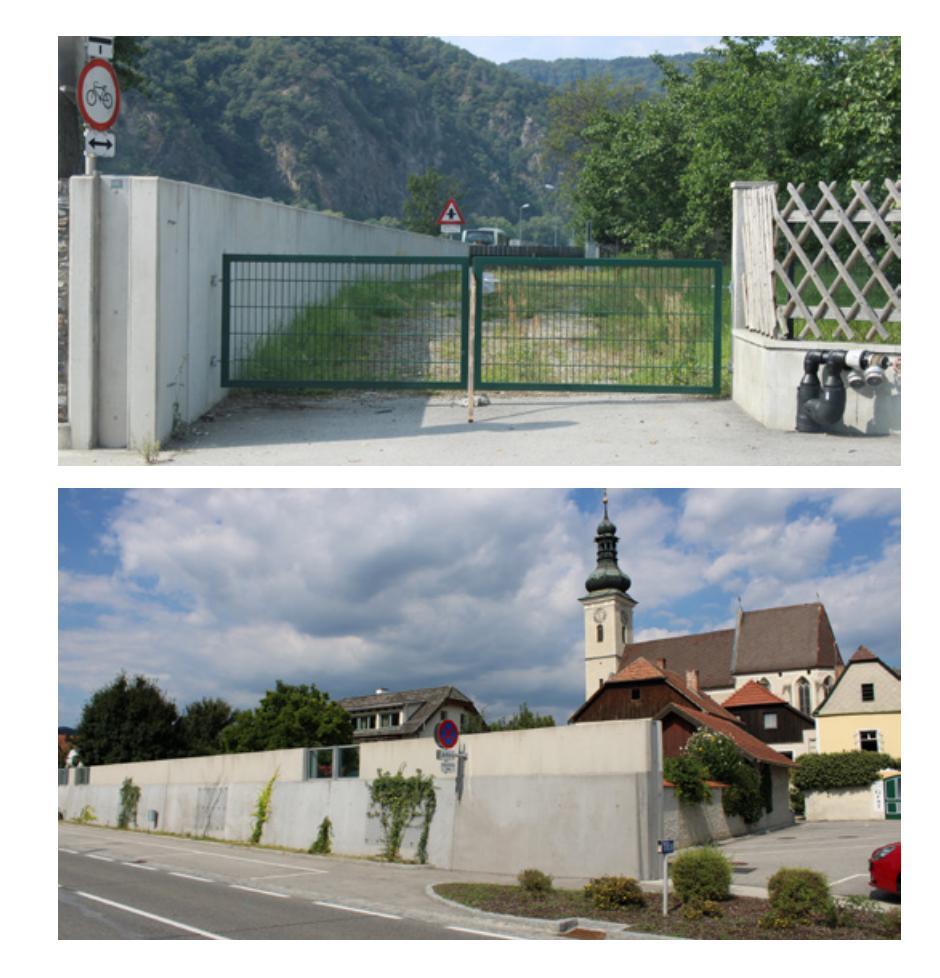
further away from the Danube. This is why they agreed on an emergency lane to be built inside the walls on their land (fig. 40), which allowed the municipality to follow the usual concept of walls and aluminium panels, though on higher base walls than usual, since the wall was integrated into an existing vineyard wall at the lower end of the village.

Upstream from the parish church, there was less space between the road and the houses, so here the whole protection was built as a very tall wall, which led to a lot of public discussion. People had forgotten, though, that there had been a similar wall here previously, but because it was overgrown with ivy it had not been perceived as a tall wall. The new wall was in fact, only about a metre higher than the previous one, which was clearly marked out by the new design (fig. 41). It was agreed that the new wall would also be covered with vegetation. However, the new bushes were planted in the extremely hot summer of 2015, and not all of them survived, so it will probably take a bit more time before the wall looks as it did before 2013. Since the base walls downstream from the parish church were meant to look like the vineyard walls they were integrated into, most of these walls were, as in Krems-Stein, covered with brick stones.

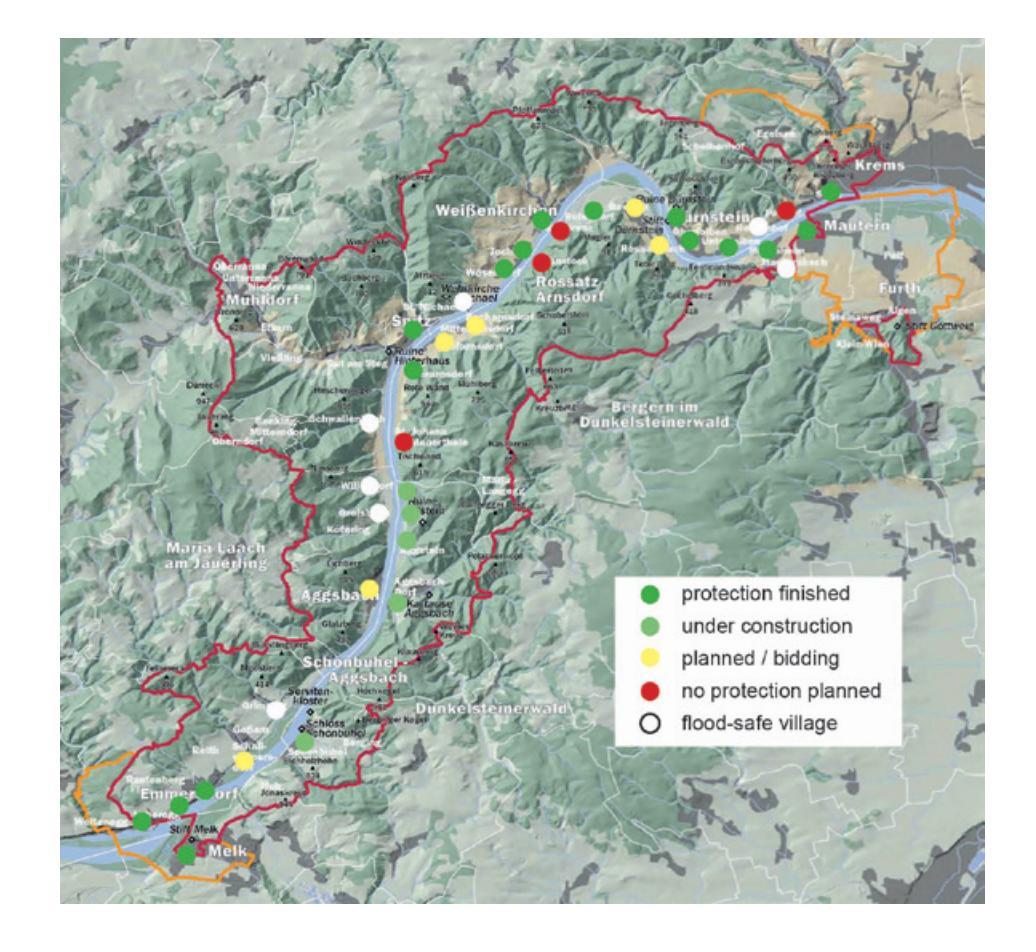
**Fig. 44.** The World Heritage region Wachau, in: Zech *et al.* 2017, 24-25, cartography M. Schimek, 2019, Overview over all flood protection projects

Currently, the two polders around Schönbühel and Aggsbach Dorf are under construction. The walls in Schönbühel will run along the village from its upstream end until the rock on which Schönbühel castle is situated using the wall-aluminium panel design and be similar in look to the schemes at Spitz and Weißenkirchen. The storage halls are being built off the main road.

Aggsbach Dorf needs a shorter wall along the Danube. On the other hand, the walls have to follow the Aggsbach creek almost a kilometre inland, since the area there is rather flat. The municipality will use the opportunity to erect a new village centre building, including storage facilities for the panels, a new municipality office and public housing, near the creek.
